Manhole Inspection Summary

Manhole # S09SS_001MH

Insp Date: **2/19/09 10:21 AM**

Location Address: **3300 CARLISLE AVE**

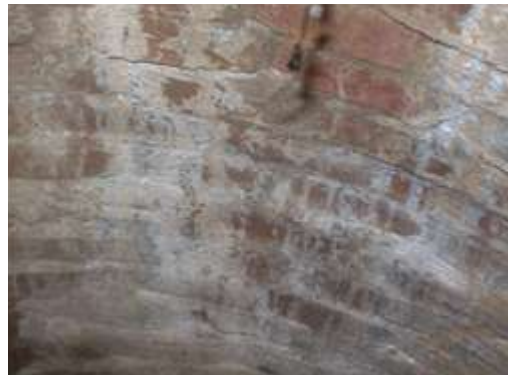
Defect 2

Condition: ☐ Sound ☒ **Cracked** ☐ Root Intrusion ☐ Loose Brick ☐ Deteriorated

CRACK IN WALL

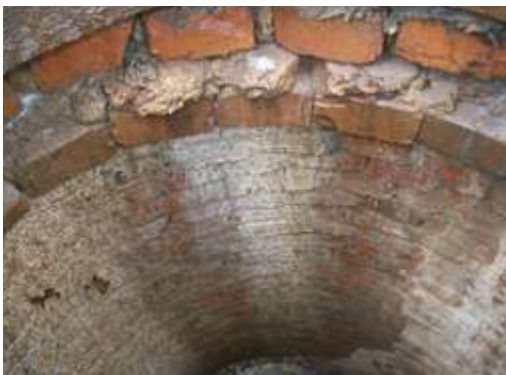
Defect 1

Condition: ☐ Sound ☐ Cracked ☐ Root Intrusion ☐ Loose Brick ☒ **Deteriorated**

Infiltration: ☐ None ☐ Joint ☒ **Cracks** ☐ Mortar ☐ Roots ☒ **Wall**

Infiltration: ☐ None ☐ Joint ☐ Cracks ☐ Mortar ☐ Roots ☒ **Wall**

deteriorated, carcked and INFILTRATION chimney. infiltration corbel

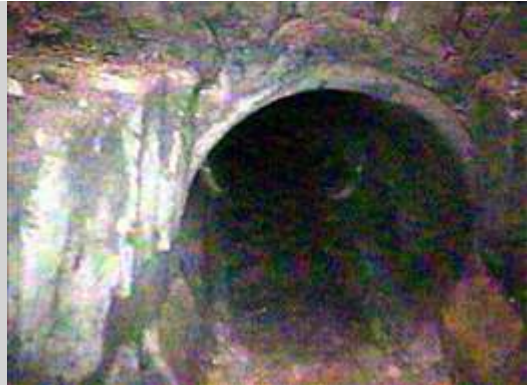
12 O'Clock Outflow

8 in. Circular Gravity Sewer
Pipe Out @ 12 O'Clock

Pipe Height: (in.) Direct
Pipe Material: **Clay** ☐ Pipe Lined
Invert Depth: **6.76** (ft.) Flow Characteristics: **Fast**
Deposits: ☒ None ☐ Mud ☐ Sludge ☐ Debris ☐ Grease
Silt Depth: (in.) Deposits Extent:
Infiltration: **None** Pipe Seal Cond: **Sound**

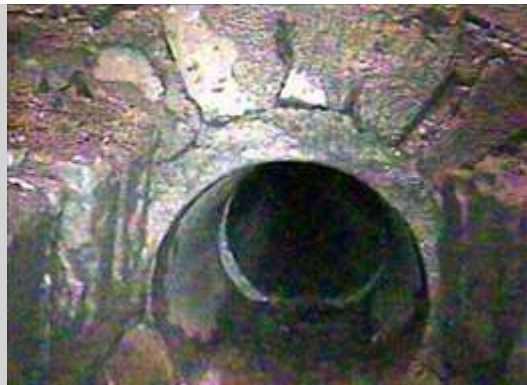
9 O'Clock Inflow

8 in. Circular Gravity Sewer
Pipe In @ 9 O'Clock

Pipe Height: (in.) Direct
Pipe Material: **Clay** ☐ Pipe Lined
Invert Depth: **6.65** (ft.) Flow Characteristics: **Fast**
Deposits: ☒ None ☐ Mud ☐ Sludge ☐ Debris ☐ Grease
Silt Depth: (in.) Deposits Extent:
Infiltration: **None** Pipe Seal Cond: **Sound**
